DRAINAGE SYSTEMS: DEVELOPMENT OF AN ASSET MANAGEMENT STRATEGY

TOP TIER COMAH INSTALLATION

ASSET COMPLIANCE

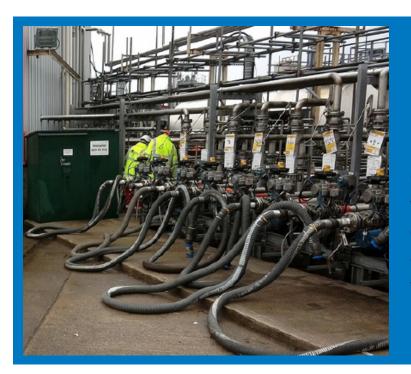
PUMPS

LIKLIHOOD OF FAILURE: HIGH

Consequence: pump failure would restrict the ability to move effluent from storage tanks discharge, reducing capacity within site attenuation.

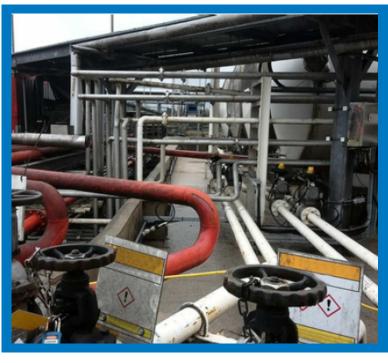
VALVES

LIKLIHOOD OF FAILURE: LOW

Consequence: valve failure would result in the inability to shut off sections of system reduce contamination build-up system.
