CASE STUDY

ABERARDER WIND FARM ENVIRONMENTAL SUPPORT

CLIENT: I & H BROWN

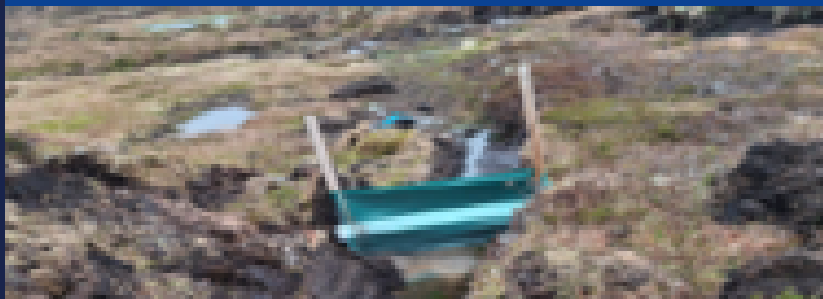
Due to the site's challenging conditions, a full-time EnCoW presence was required. The steep topography and multiple intersecting watercourses significantly increased the risk of sediment mobilisation and potential pollution events. To effectively manage these risks, daily turbidity monitoring was undertaken and recorded within a bespoke tracking tool.

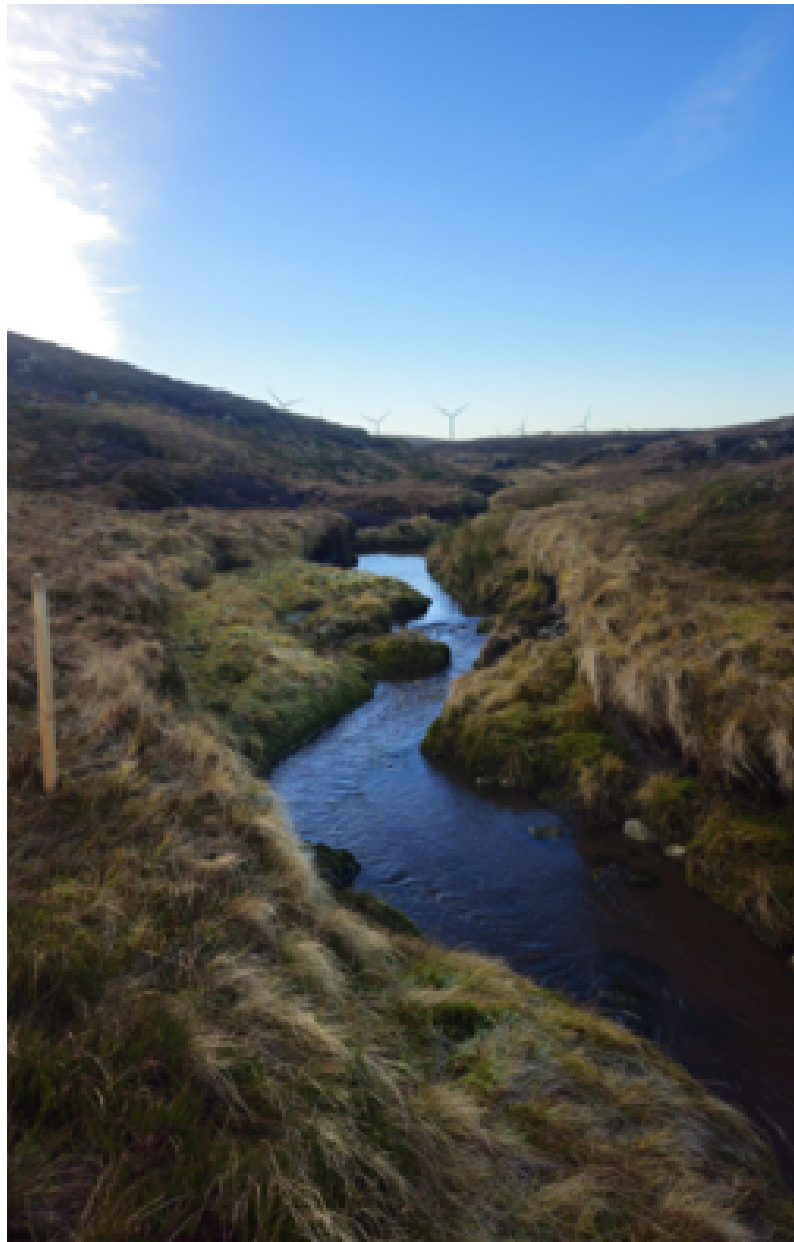
The EnCoW undertook daily site inspections, during which a minimum of three turbidity samples were collected, including a control sample taken from outside the red-line boundary to provide a robust baseline for comparison. Inspections focused on identifying high-risk areas for potential run-off, with particular attention to exposed soils, steep gradients, and locations adjacent to watercourses. The EnCoW also assessed the condition and effectiveness of existing mitigation measures such as silt fencing, check dams, and settlement ponds to determine whether maintenance, reinforcement, or replacement was required. Where elevated risks of sediment mobilisation or run-off were identified, the EnCoW provided recommendations for the installation of additional interventions to ensure continued environmental protection.

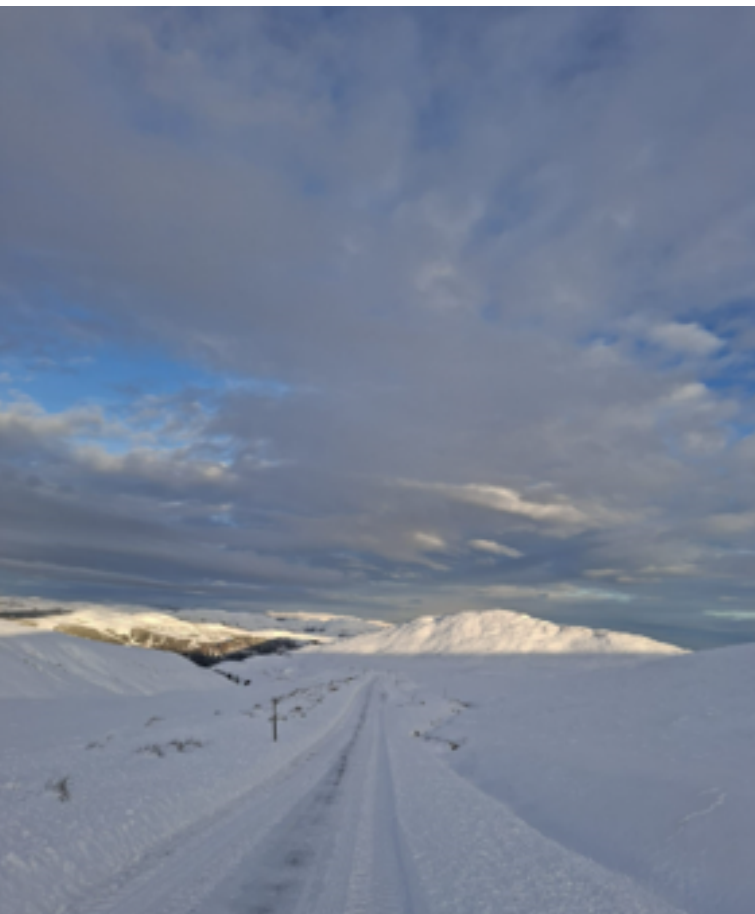
When installing ditching near turbine bases, spatial constraints were encountered due to the proximity of ecological exclusion zones. To avoid disturbance, no plant or personnel were permitted to enter these protected areas. As a result, the ditching was positioned as far from the exclusion zone boundaries as reasonably practicable, while still achieving effective water management. This required careful planning and collaboration between the EnCoW and construction teams to balance ecological protection with engineering requirements.
